Windrift Condos

Level 2 Reserve Study

Type of Study	Update w/Site Visit
Date of Property Inspection	05/03/2023
Prepared By	Dale Gifford
Analysis Method	Cash Flow
Funding Goal	Full Funding

Executive Summary – Windrift Condos - ID # 17479

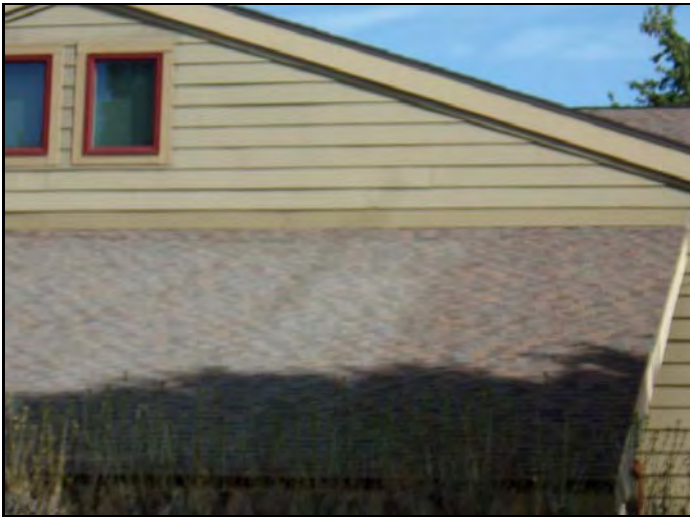
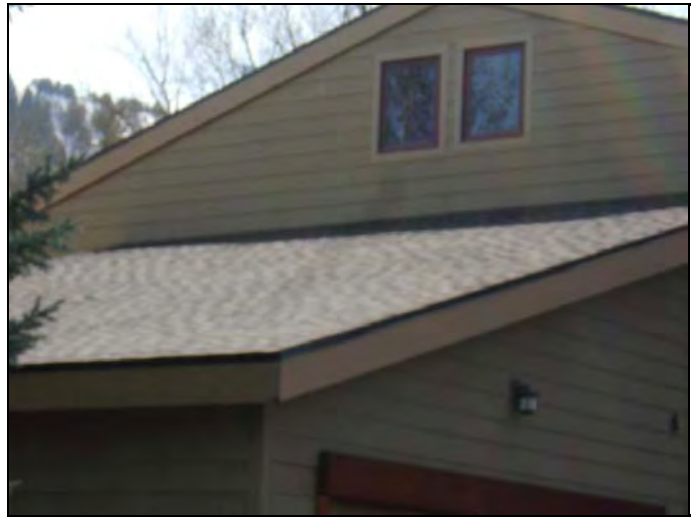
Comp #: 105 Roofs - Bldg 1 & 2 - Replace

Location: Buildings 1 & 2 Roofs

The roofs are in good condition. We recommend funding to replace this component approximately every 25 - 30 years. Remaining life based on current age.

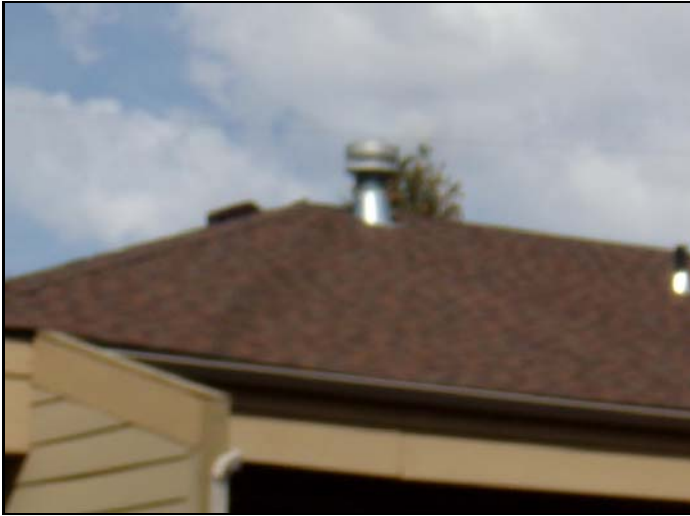
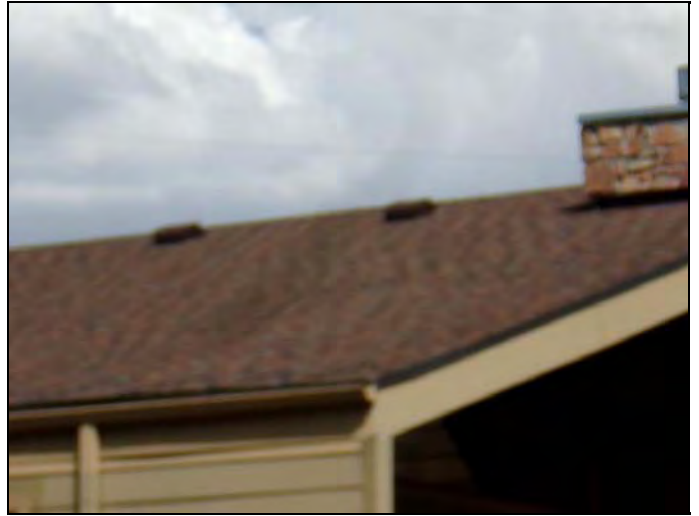
Comp #: 105 Roofs - Bldg 3 - Replace

Location: **Building 3 Roof**

The roofs are in good condition. We recommend funding to replace this component approximately every 25 - 30 years. Remaining life based on current age.

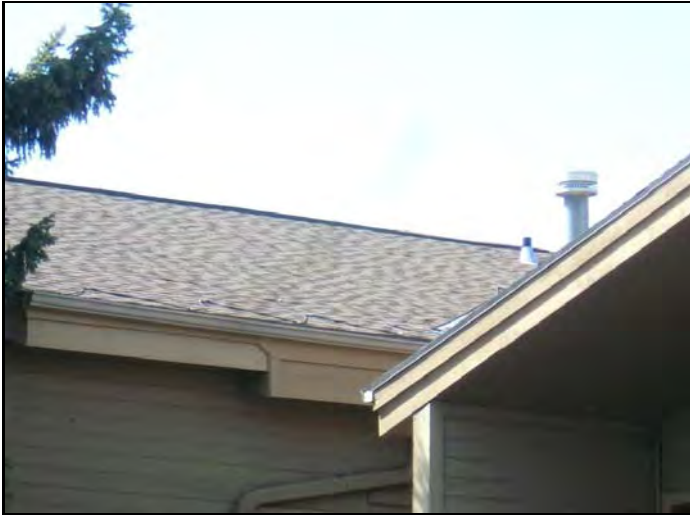
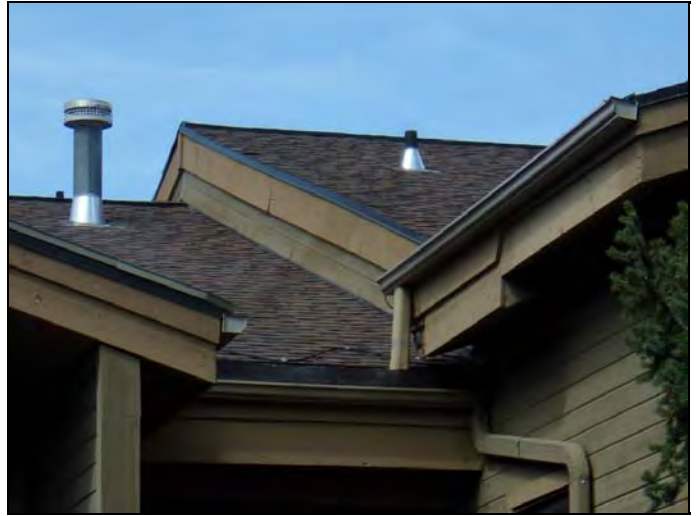
Comp #: 105 Roofs - Bldg 4 - Replace

Location: **Building 4 Roof**

The roofs are in good condition. We recommend funding to replace this component approximately every 25 - 30 years. Remaining life based on current age.

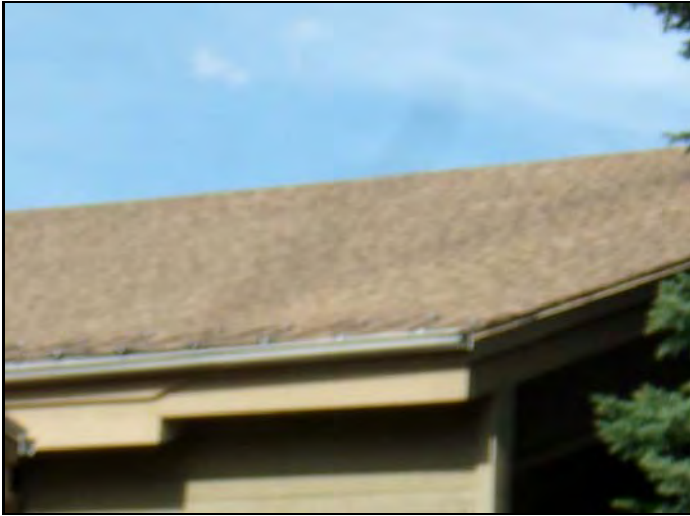
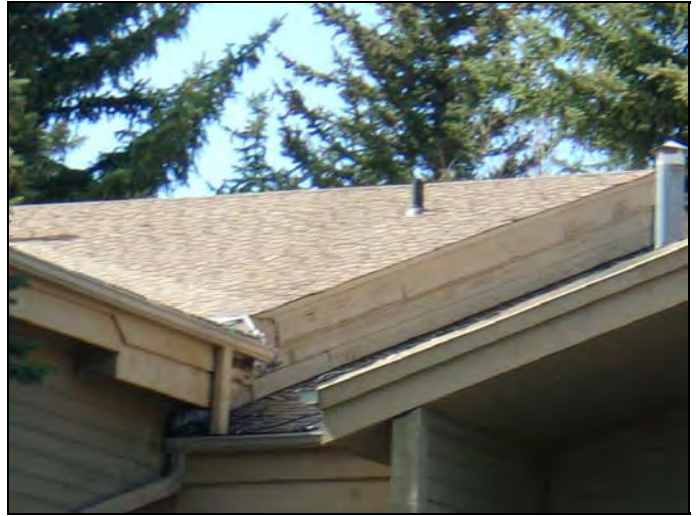
Comp #: 105 Roofs - Bldg 5 - Replace

Location: **Building 5 Roof**

Research with the client reveals this component will be replaced in 2023. We recommend funding to replace this component approximately every 25 - 30 years. Remaining life based on current age.

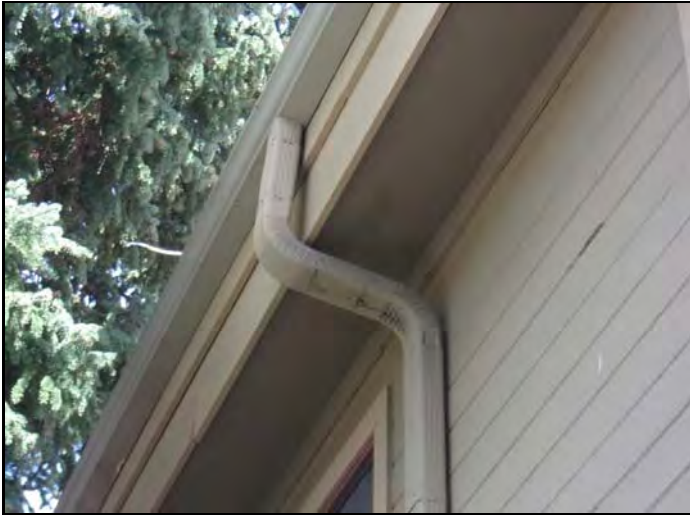
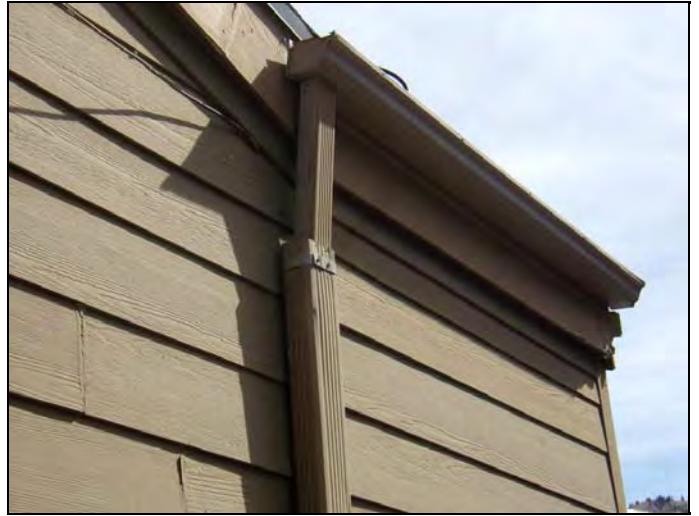
Comp #: 120 Rain Gutters/Downspouts - Replace

Location: **Building Exteriors**

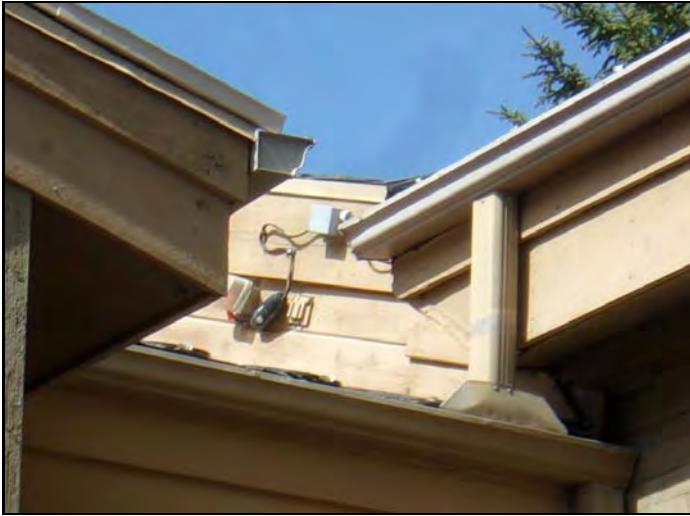
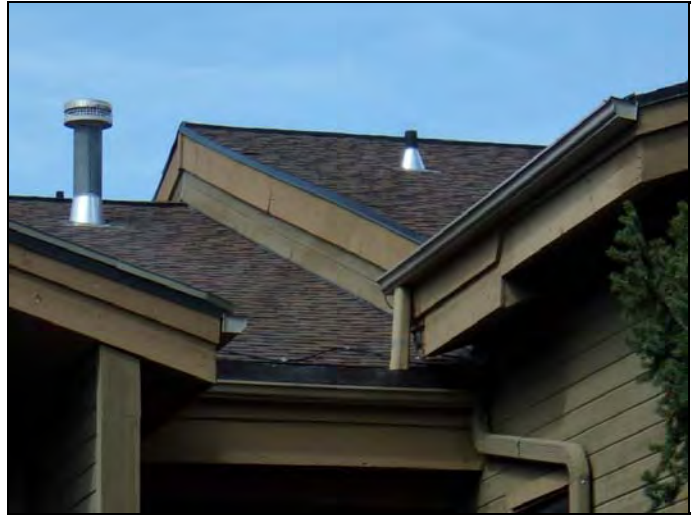
Comp #: 121 Heat Tape - Replace

Location: **Building Exteriors**

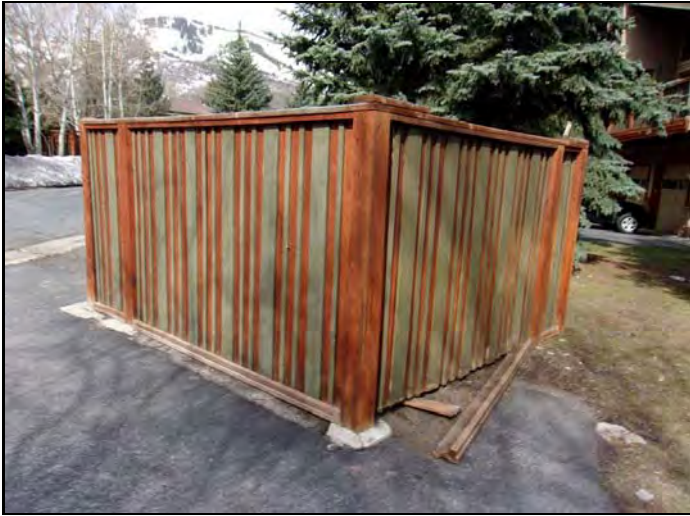
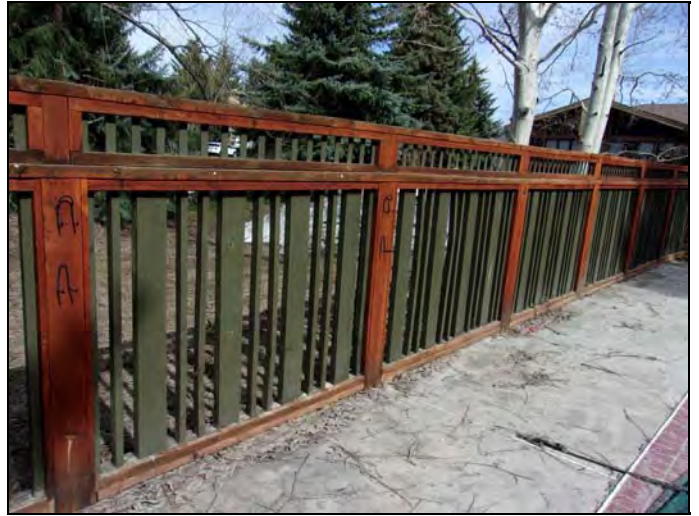
Comp #: 209 Wood Fencing - Repaint

Location: **Dumpster Enclosure & Pool Area**

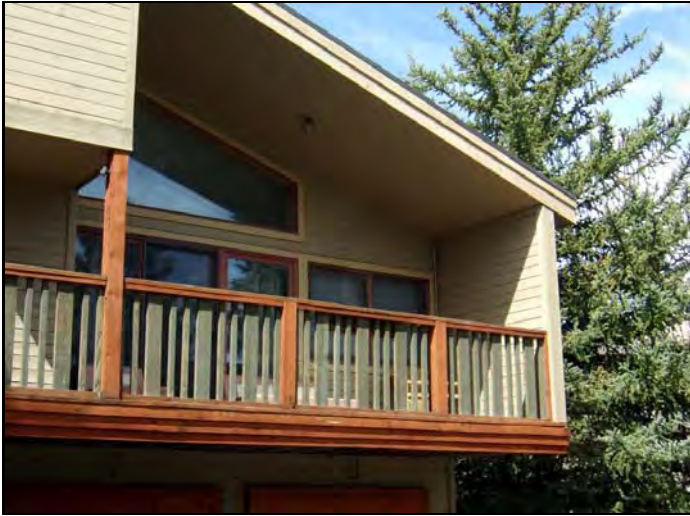
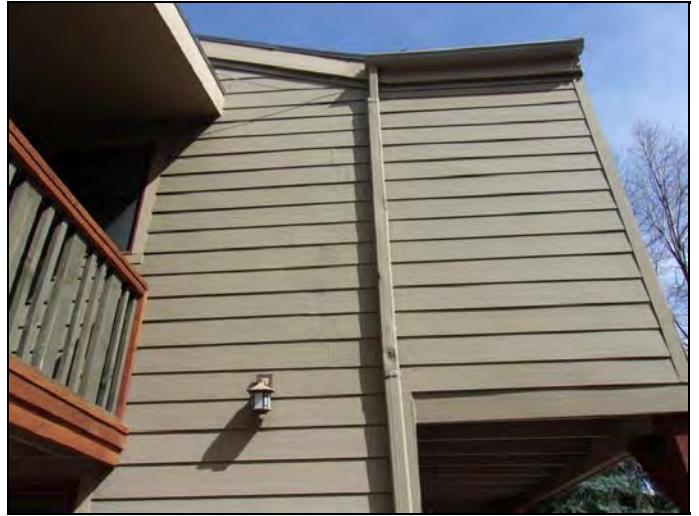
Comp #: 215 Building Exteriors - Partial Repaint

Location: **Building Exteriors**

<p>Quantity description:</p> <p>(2) - 12,205 SF - Large Buildings, North of Saddle View Way</p> <p>(1) - 9,700 SF - Large Building, South of Saddle View Way</p> <p>(2) - 6,400 SF - Small Buildings, South of Saddle View Way</p> <p>46,910 SF - Total</p>
--

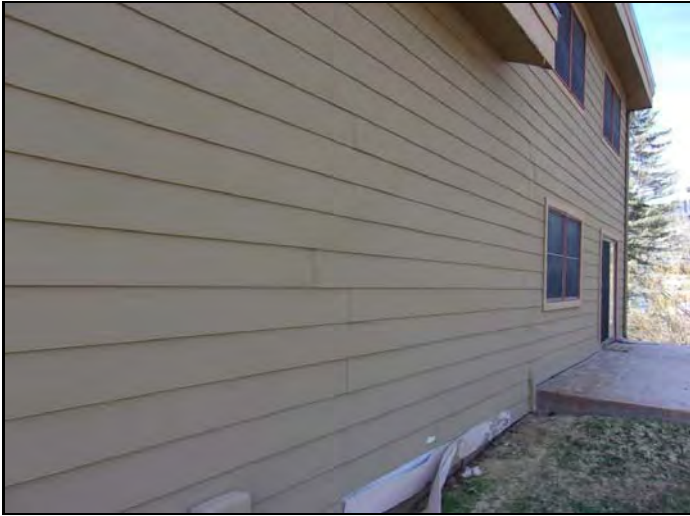
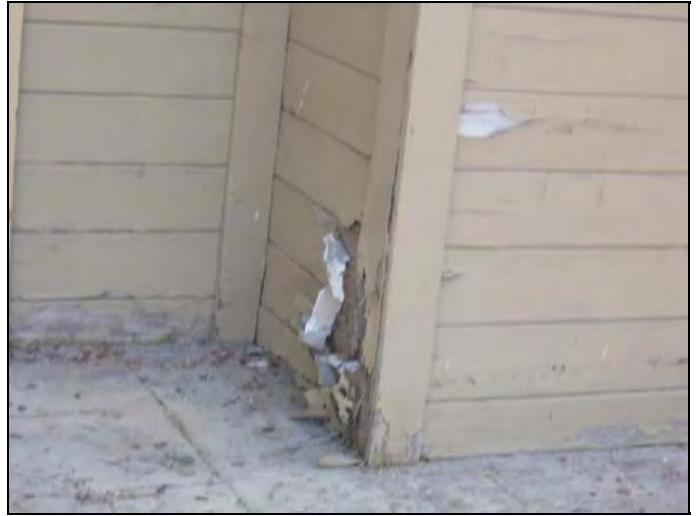
Comp #: 303 Building Exteriors - Partial Repair/Replace

Location: **Building Exteriors**

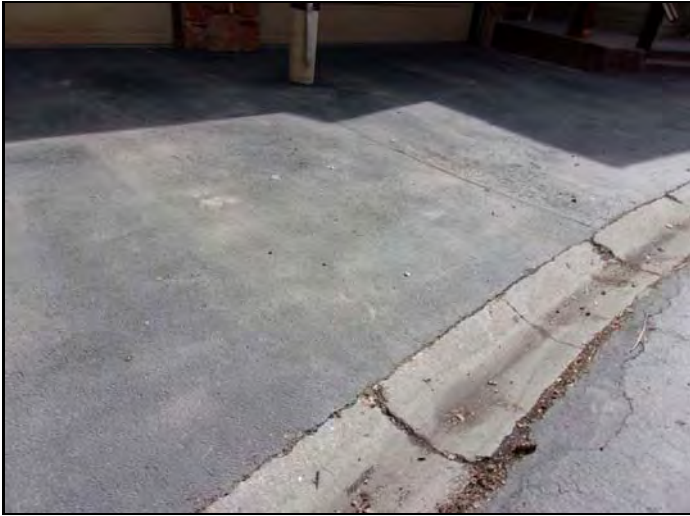
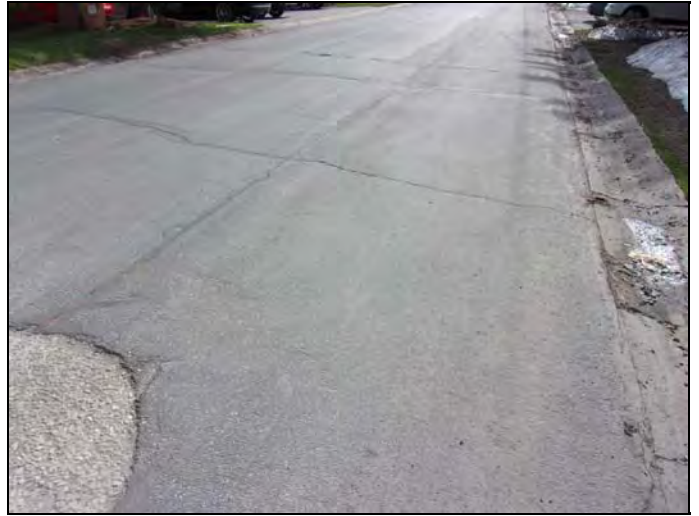
Comp #: 401 Asphalt - Major Rehab

Location: **Community Driveways, Parking & Streets**

The asphalt surfaces are in good to fair condition. We recommend funding for a major rehab of this component approximately every 25 - 30 years. Remaining life based on current age.

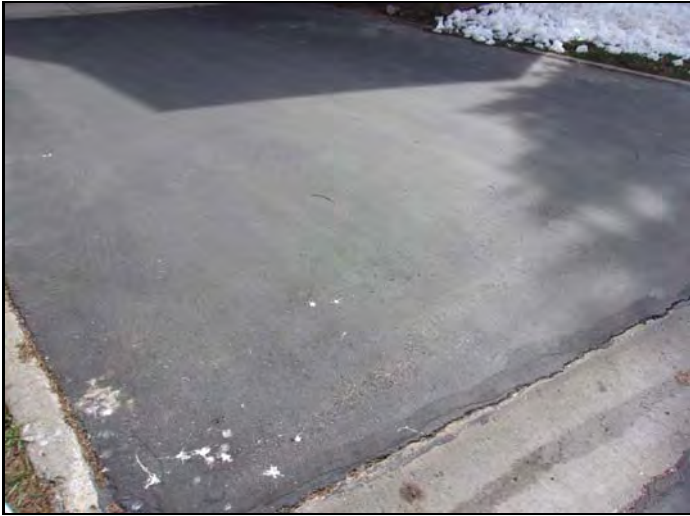
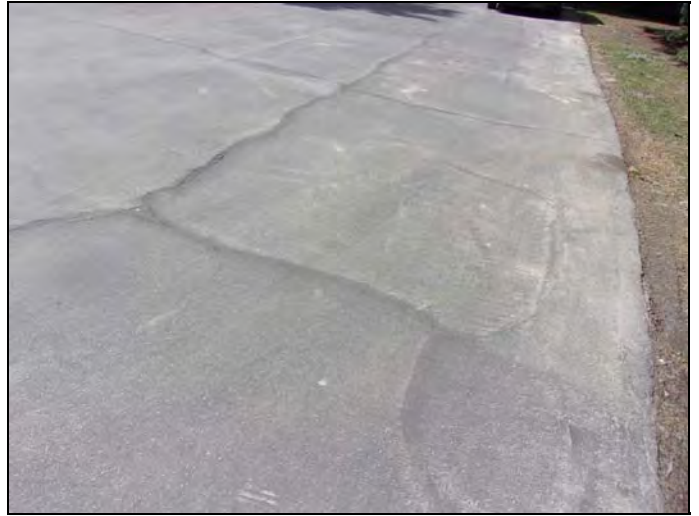
Comp #: 402 Asphalt - Seal Coat

Location: **Community Driveways, Parking & Streets**

Research with the client reveal this component will be performed in 2024. We recommend funding to seal this component approximately every 3 - 5 years. Remaining life based on current age.

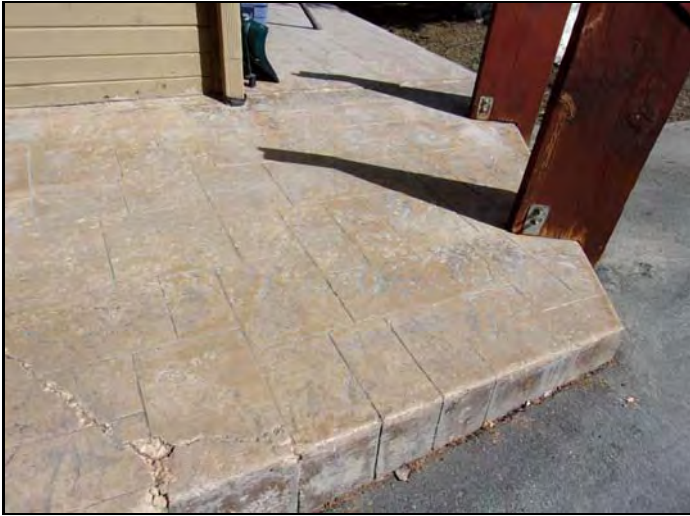
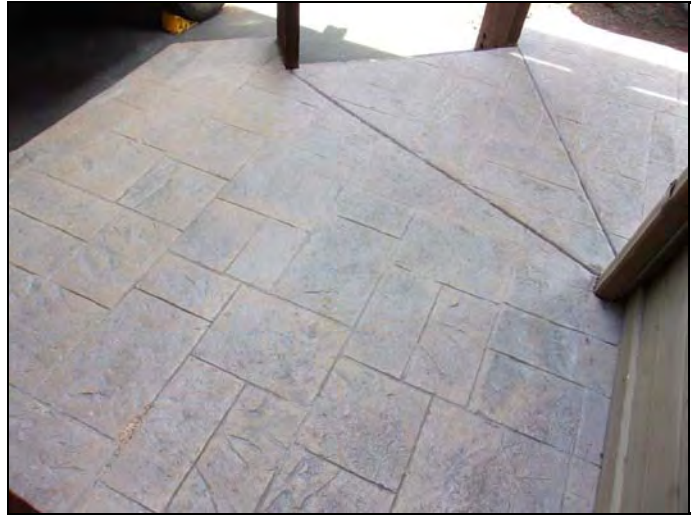
Comp #: 403 Concrete - Partial Repair/Replace

Location: **Common Area**

The concrete is generally in good condition. This component has an extended useful life under normal conditions. We recommend funding to make repairs and partially replace this component approximately every 3 - 5 years. Remaining life based on current age.

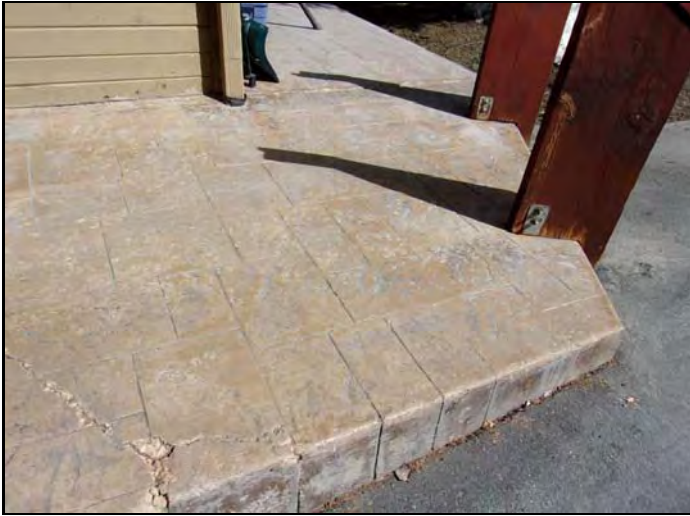
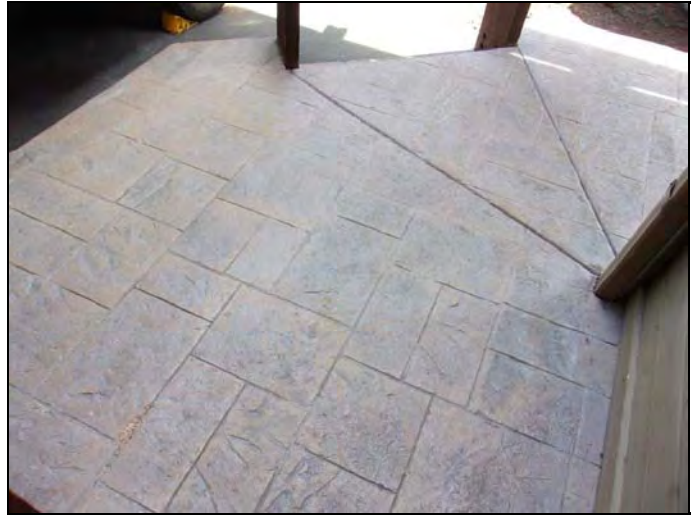
Comp #: 601 Concrete Decks - Seal

Location: **Building Exteriors**

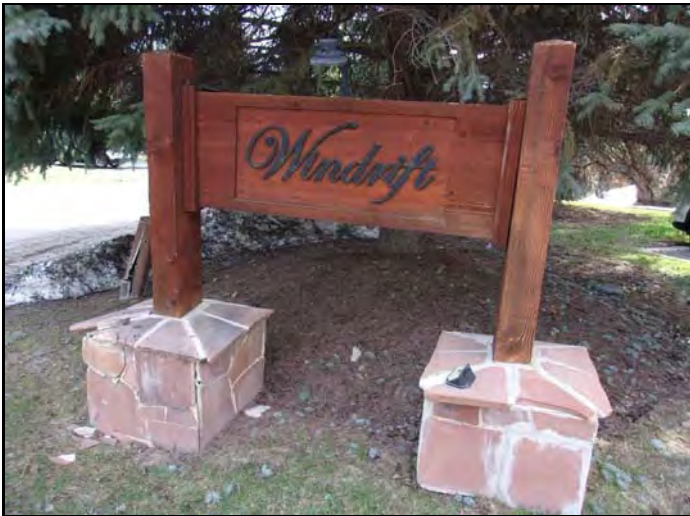
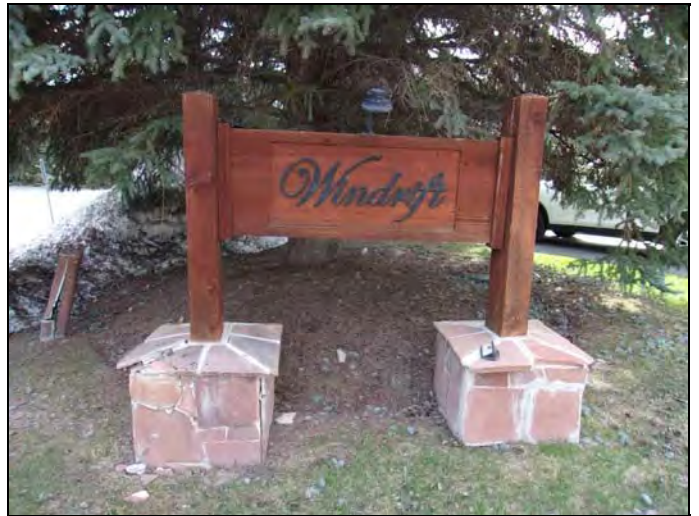
Comp #: 801 Monument Sign - Replace

Location: **Common Area**

The monument sign is in good to fair condition. We recommend funding to refurbish this component approximately every 15 - 20 years. Remaining life is based on current age.

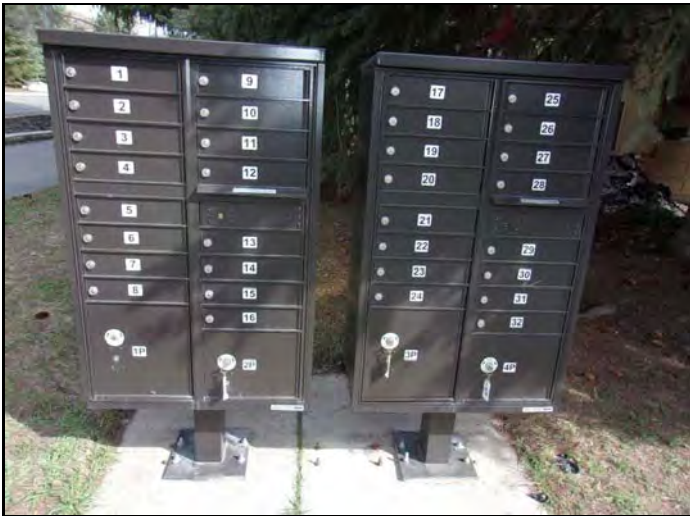
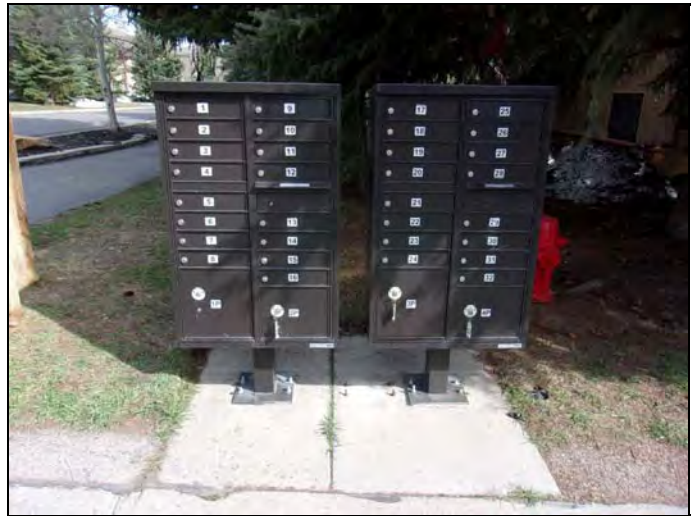
Comp #: 803 Mailboxes - Replace

Location: **Common Area**

The mailboxes are in good condition. We recommend funding to replace this component approximately every 20 - 25 years. Remaining life based on current age.

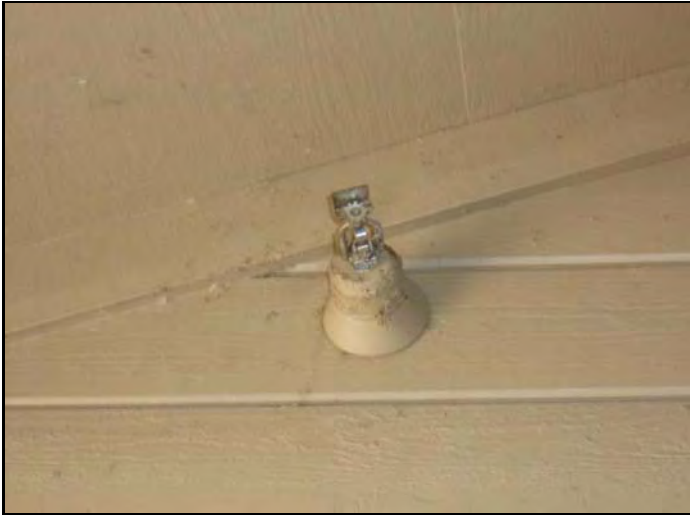
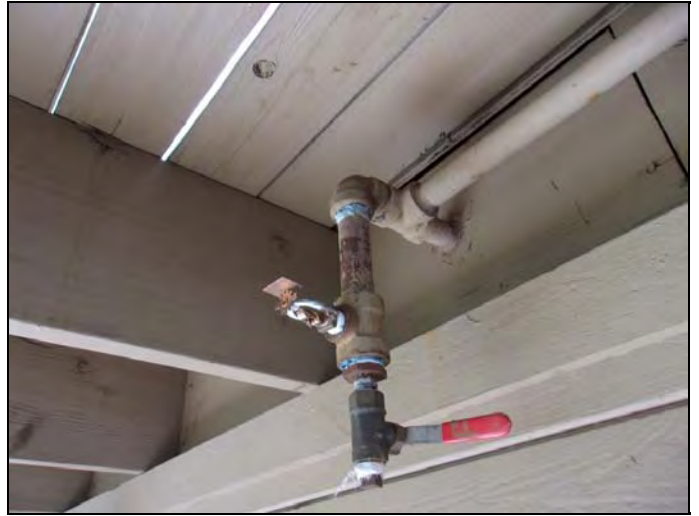
Comp #: 901 Fire Protection System - Repairs

Location: **Buildings 4 & 5**

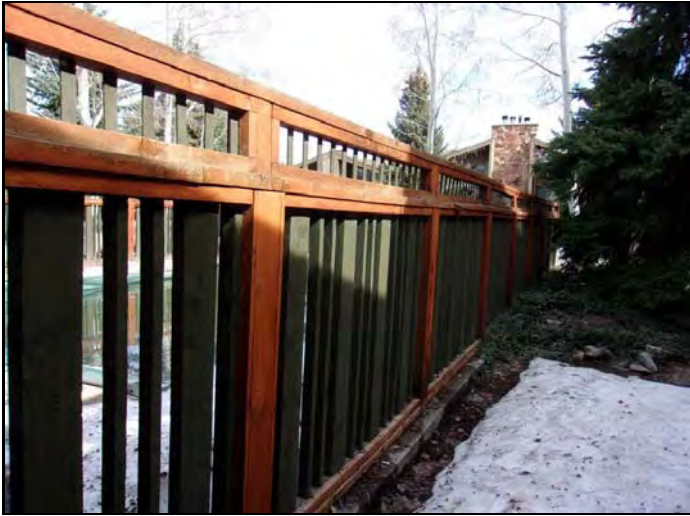
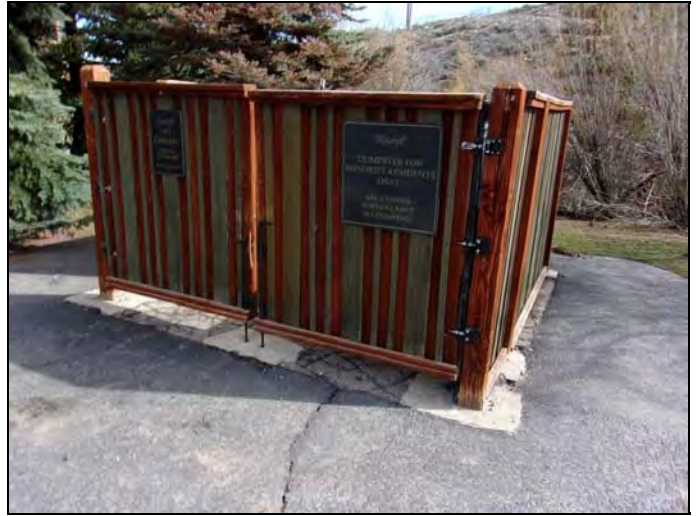
Comp #: 1001 Wood Fencing - Replace

Location: **Dumpster Enclosure & Pool Area**

The wood fencing is in good condition. We recommend funding to replace this component approximately every 25 - 30 years. Remaining life based on current condition.

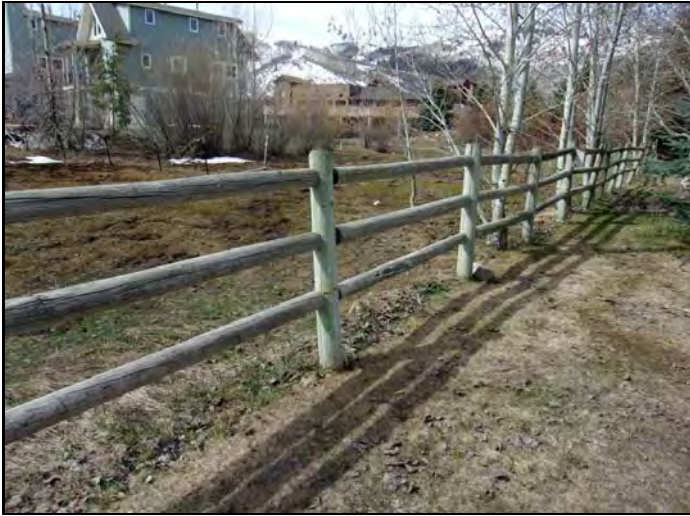
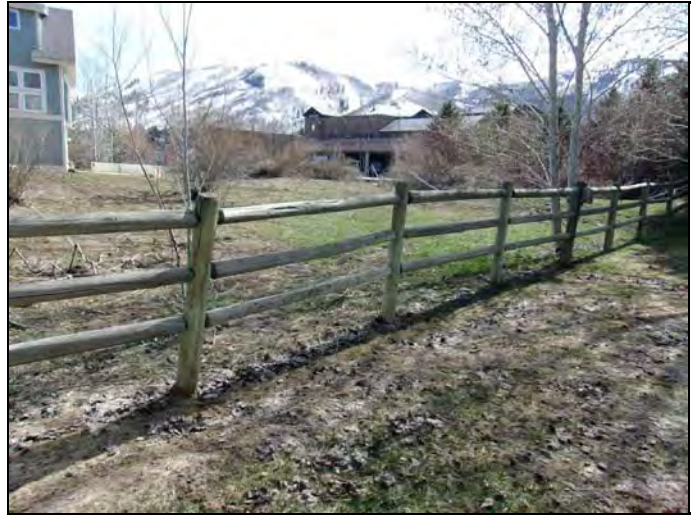
Comp #: 1009 Three Rail Fencing - Replace

Location: **Community South Perimeter**

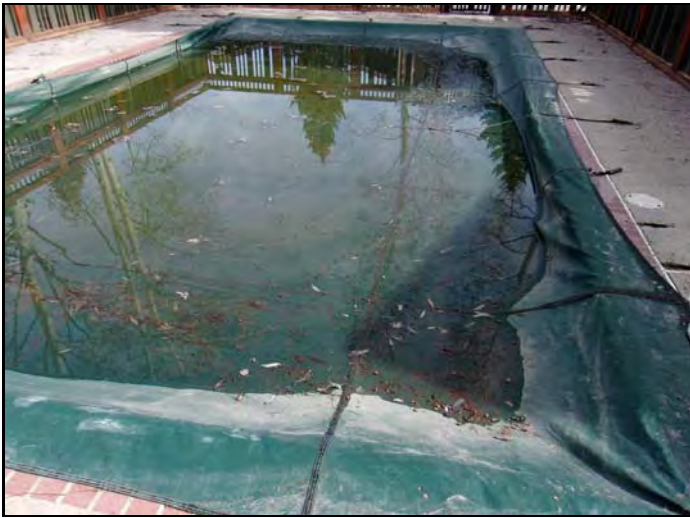
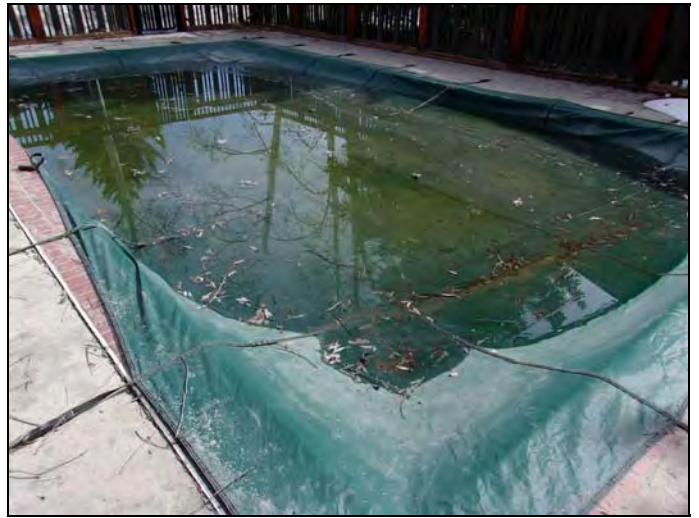
Comp #: 1101 Pool - Resurface

Location: **Pool Area**

Unable to inspect this component at the time of the site visit. We recommend funding to resurface this component every 10 - 12 years. Remaining life based on current age.

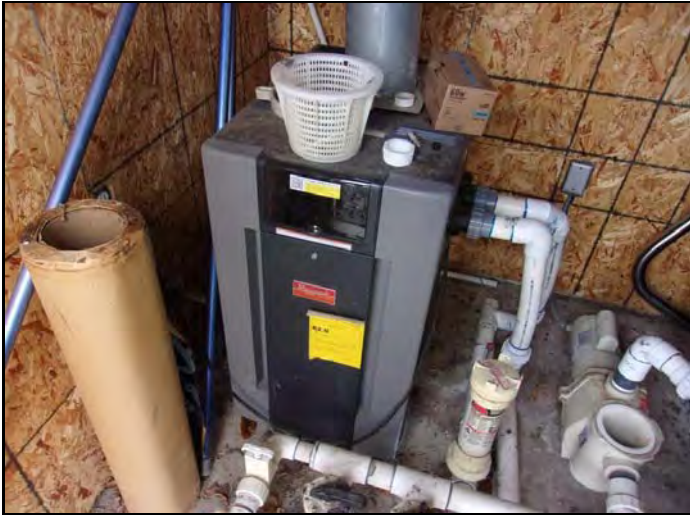
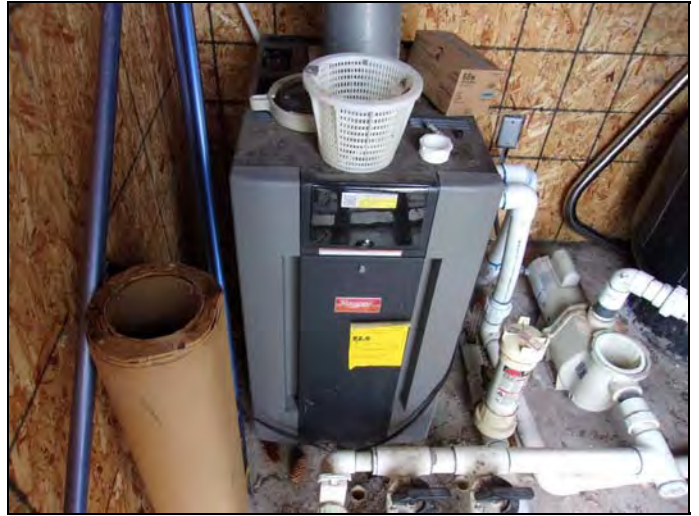
Comp #: 1104 Pool Heater - Replace

Location: **Pool Equipment Building**

The pool heater is in working condition. We recommend funding to replace this component approximately every 12 years. Remaining life based on current age.

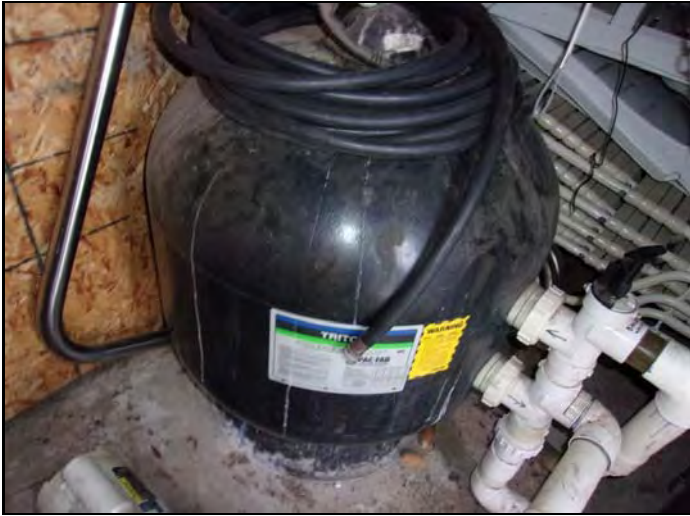
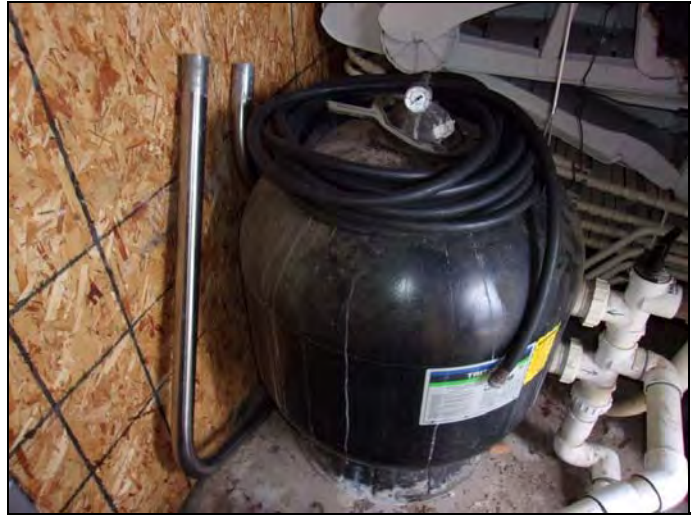
Comp #: 1107 Pool Filter - Replace

Location: **Pool Equipment Building**

The pool filter is in working condition. We recommend funding to replace this component approximately every 12 - 15 years. Remaining life based on current age.

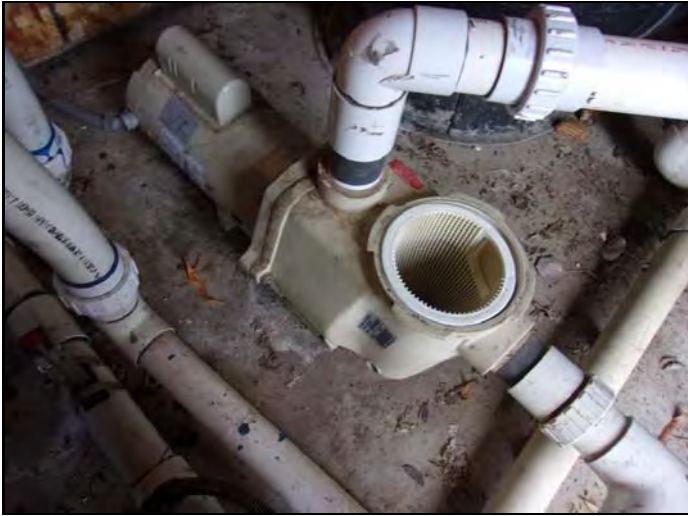
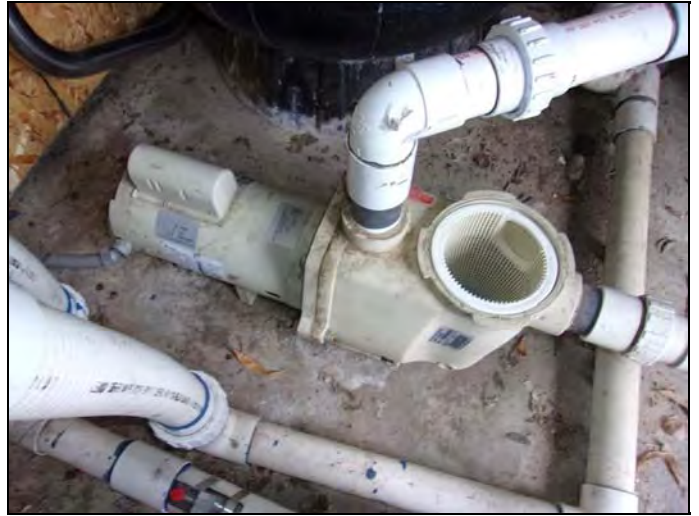
Comp #: 1110 Pool Pump - Replace

Location: **Pool Equipment Building**

The pool pump is in working condition. We recommend funding to replace this component approximately every 8 - 10 years. Remaining life based on current age.

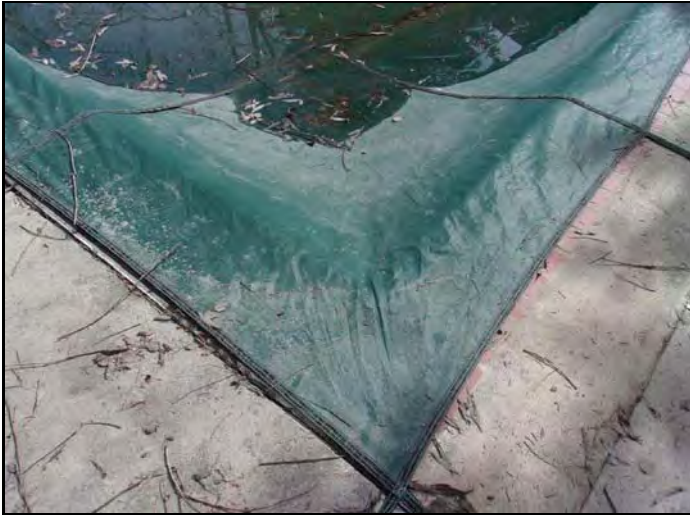
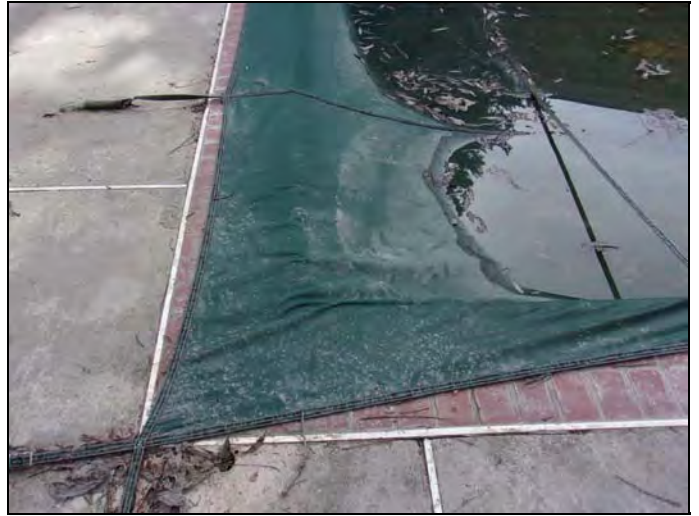
Comp #: 1112 Pool Cover - Replace

Location: **Pool Area**

The pool cover appears to be in fair to poor condition. We recommend funding to replace this component approximately every 10 years. Remaining life based on current condition.

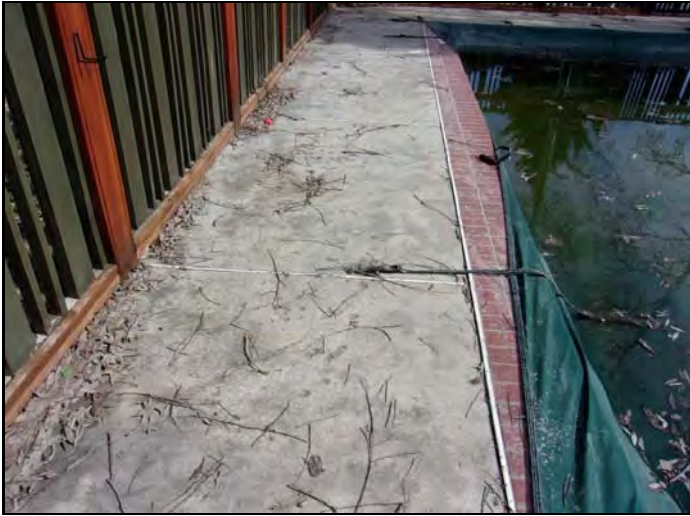
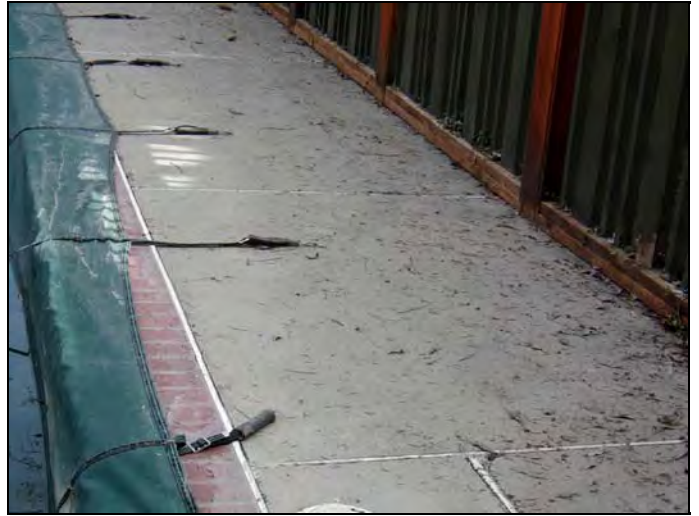
Comp #: 1116 Pool Deck - Replace

Location: **Pool Area**

The pool deck is in good to fair condition. We recommend funding to replace this component approximately every 40 - 50 years. Remaining life based on current age and condition.

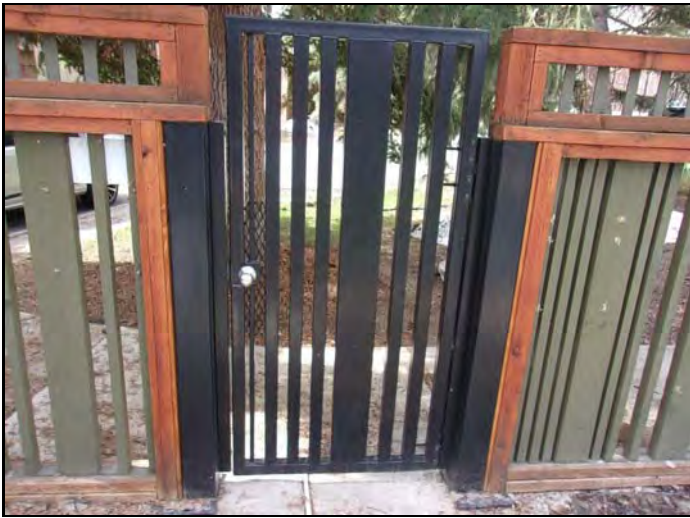
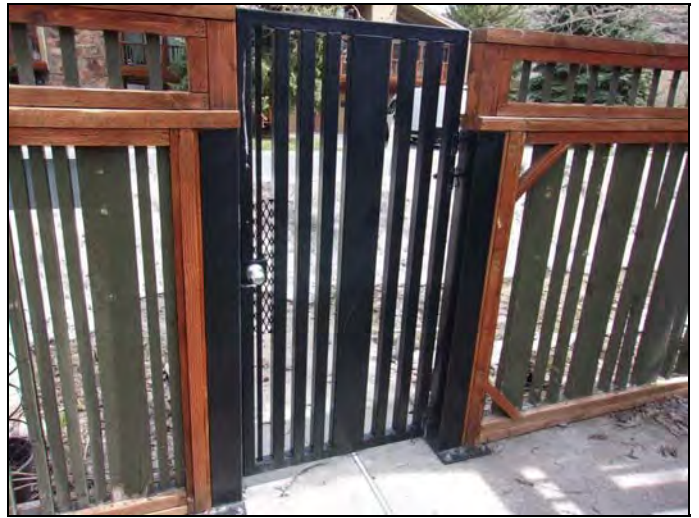
Comp #: 1190 Pool Gates - Replace

Location: **Pool Area**

The pool gates are in good condition. We recommend funding to completely replace this component approximately every 25 - 30 years. Remaining life based on current age.

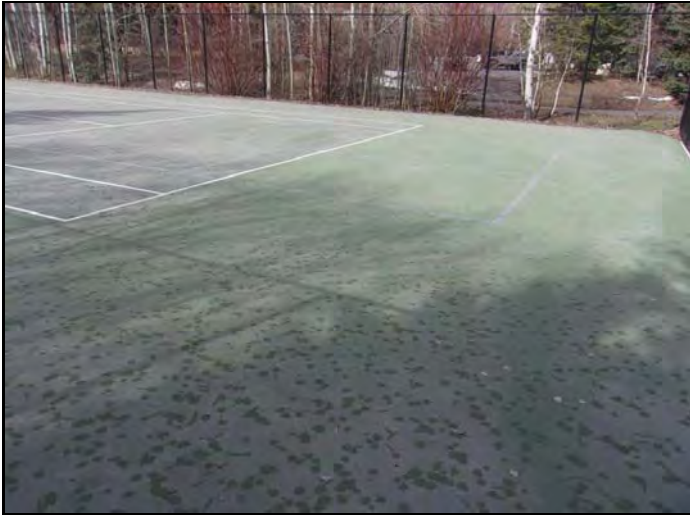
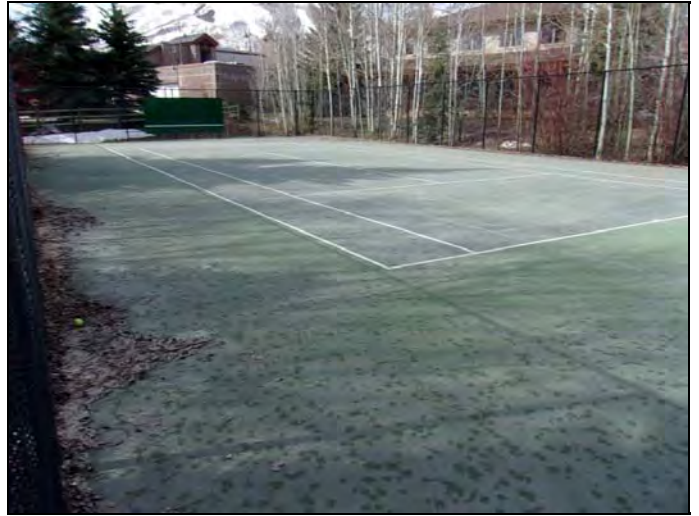
Comp #: 1201 Tennis Court - Resurface

Location: **Tennis Court**

The tennis court surface is in good condition. We recommend funding to resurface this component approximately every 8 - 10 years. Remaining life based on current age.

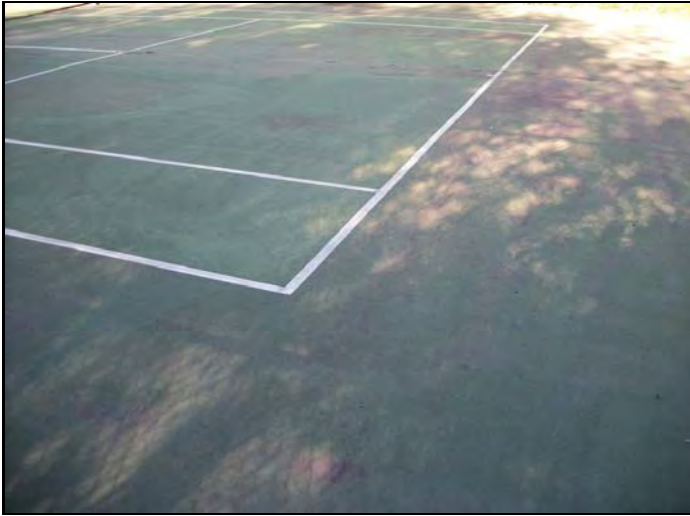
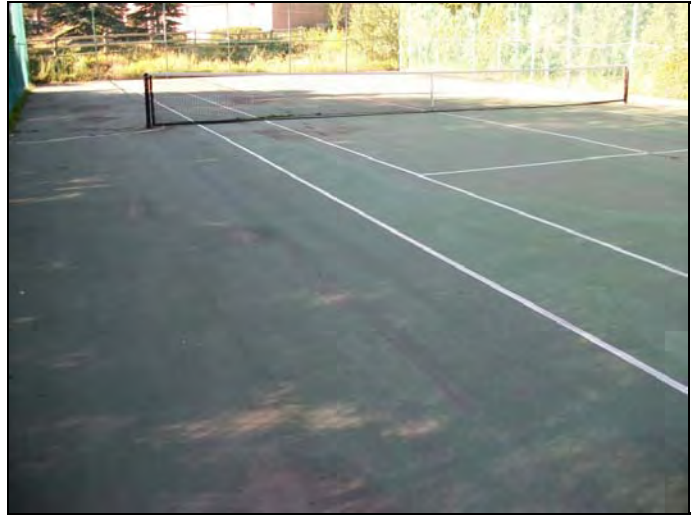
Comp #: 1203 Tennis Court - Replace

Location: **Common Area**

The tennis court is in good condition. We recommend funding to replace this component approximately every 40 - 50 years. Remaining life based on current age.

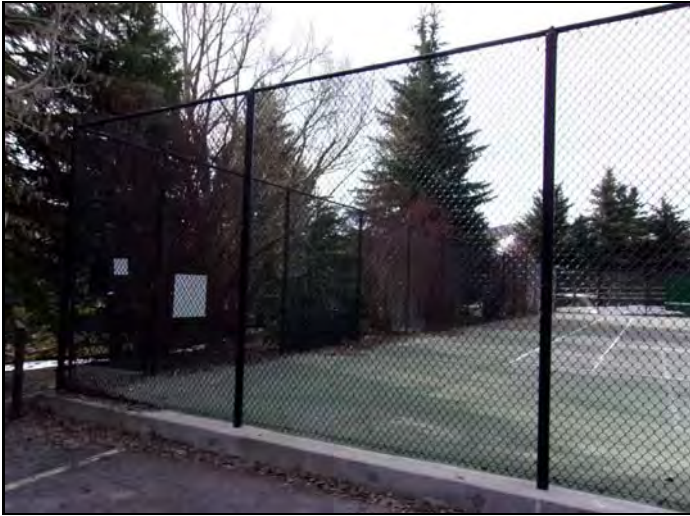
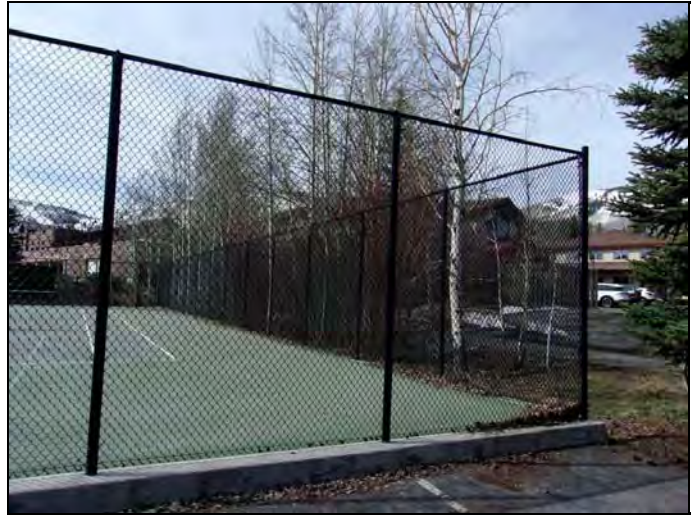
Comp #: 1290 Tennis Court Fencing - Replace

Location: **Tennis Court Perimeter**

This component is replaced as a part of Component #1203 Tennis Court Replace. No extra reserve funding necessary.

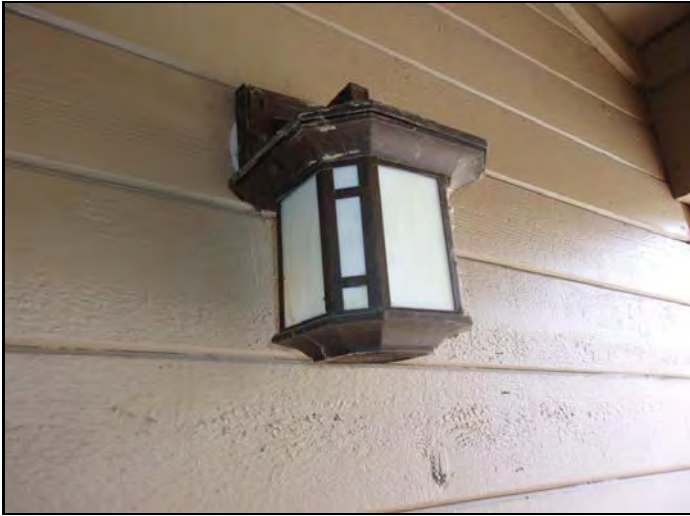
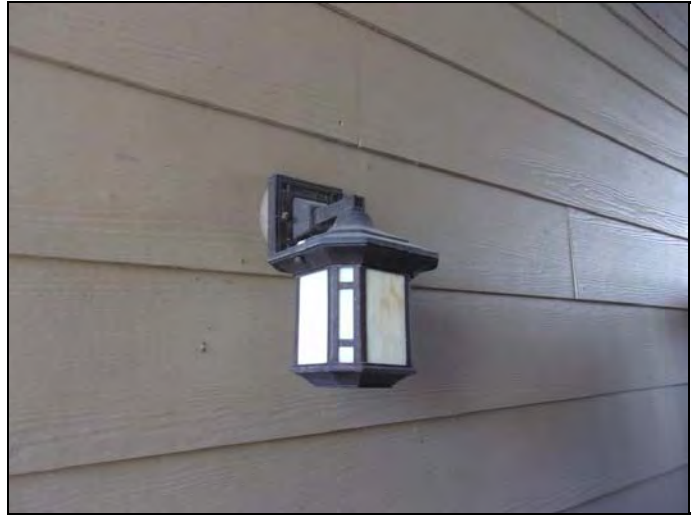
Comp #: 1602 Exterior Light Fixtures - 2005 - Replace

Location: **Building Exteriors**

The exterior light fixtures are in good to fair condition. We recommend funding to replace this component approximately every 16 - 20 years. Remaining life based on current age and condition.
