Windrift Condos

Level 2 Reserve Study

Type of Study	Update w/Site Visit
Date of Property Inspection	05/03/2023
Prepared By	Dale Gifford
Analysis Method	Cash Flow
Funding Goal	Full Funding

Executive Summary – Windrift Condos - ID # 17479

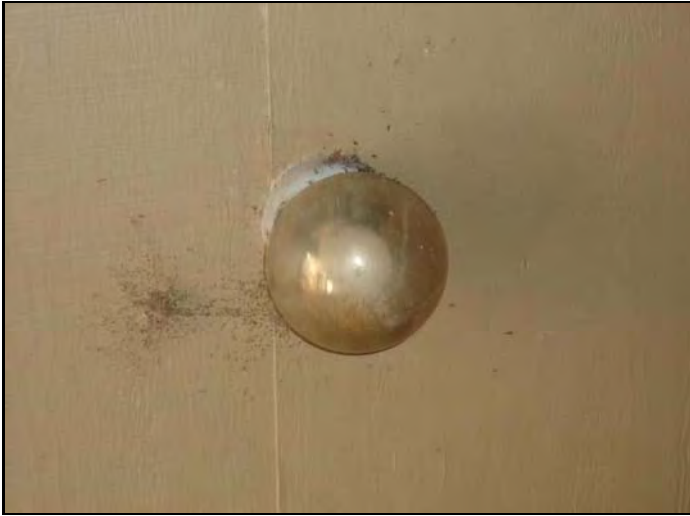
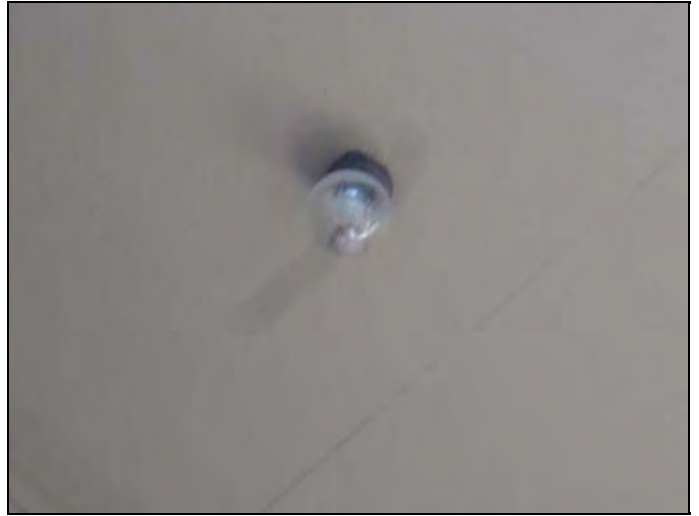
Comp #: 1602 Exterior Light Fixtures - Old - Replace

Location: **Building Exteriors**

The exterior light fixtures are in working condition. We recommend funding to replace this component approximately every 16 - 20 years. Remaining life based on current age and condition.
